The Corkscrew

Wimborne Railway Society

Issue 132 December 2022

Bridging the Stour at Wimborne

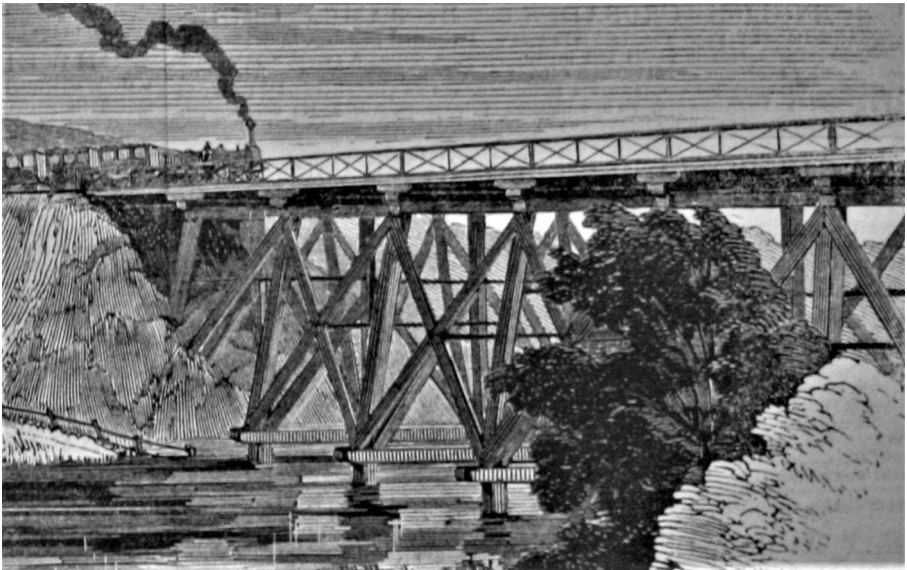
Fig. 1. The Stour viaduct.

Extracted from *Illustrated London News* (5 June 1847).

However we have no engineering drawings of the Stour viaduct as built, and evidence from the well-known engraving in the *Illustrated London News* is ambiguous.

Although it is important to remember such depictions were never intended to be taken literally, there are good reasons to think that, once allowance is made for the obvious vertical distortion, much of the general scene at Wimborne was fairly accurately drawn.

Moreover Dr Nicholas Bill, an expert on early-railway timber structures, thinks the depiction of the viaduct is plausible although he doubts that the riverbed piles would have been vertical – the raking timbers probably continued down into the water, as shown in the earlier, single-track design. What then are we to make of the comparison with the ILN's engraving of Peto's earlier structure?

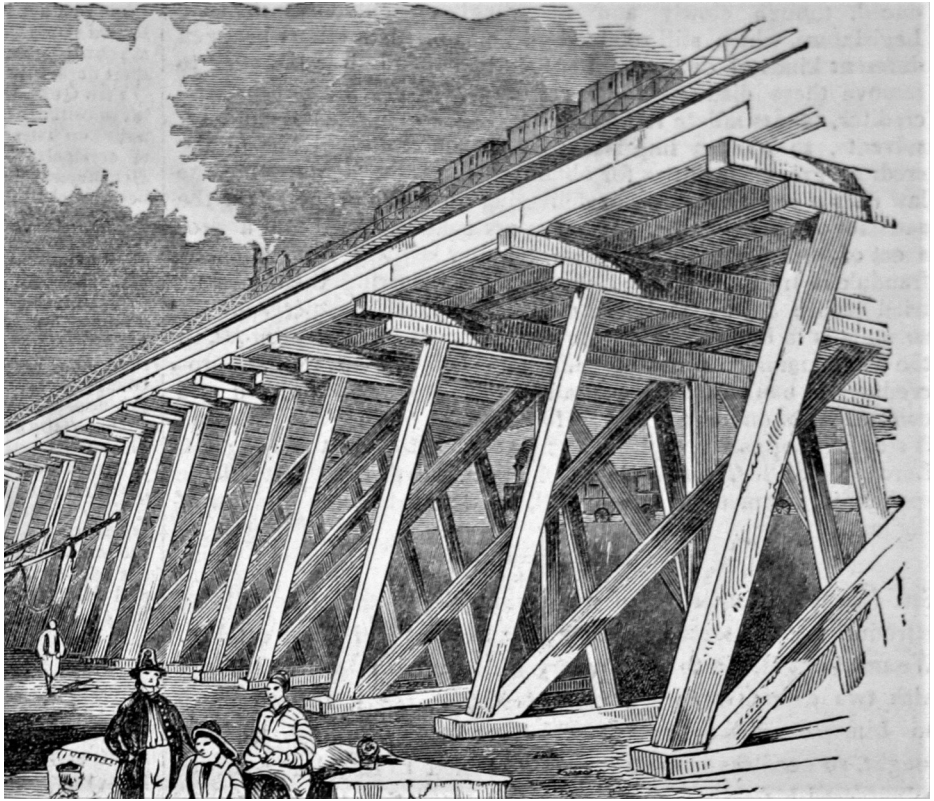
Fig. 2. The Bricklayers Arms viaduct.

Extracted from *Illustrated London News* (4 May 1844).

There is an obvious similarity to the fencing. More significantly, the double beams supporting the trackbed at Bricklayers Arms agree with the description Coddington gave for spans of 18 feet or more on the S&D, although this detail cannot be made out with any certainty for the Stour viaduct. All this weighs a little in favour of a design input from Peto, or at least his agent. So too does the fact that some contractors did not have a high opinion of Moorsom; one of his major designs – a timber-lattice bridge over the River Nore on Waterford & Kilkenny Railway (1846) – was reputed to have been found wanting and re-worked by the contractor. On the other hand it is hard to make out the detail of the internal bracing to the trestles at Wimborne – it *might* be “similar” to that at Bricklayers Arms. And an obvious difference between the two designs lies with the cross-braced timbers between trestles, along with the – presumably iron – lateral tie rods. Coddington made no note of these features, making it harder to be convinced that his Bricklayers Arms reference applied to the Stour viaduct.

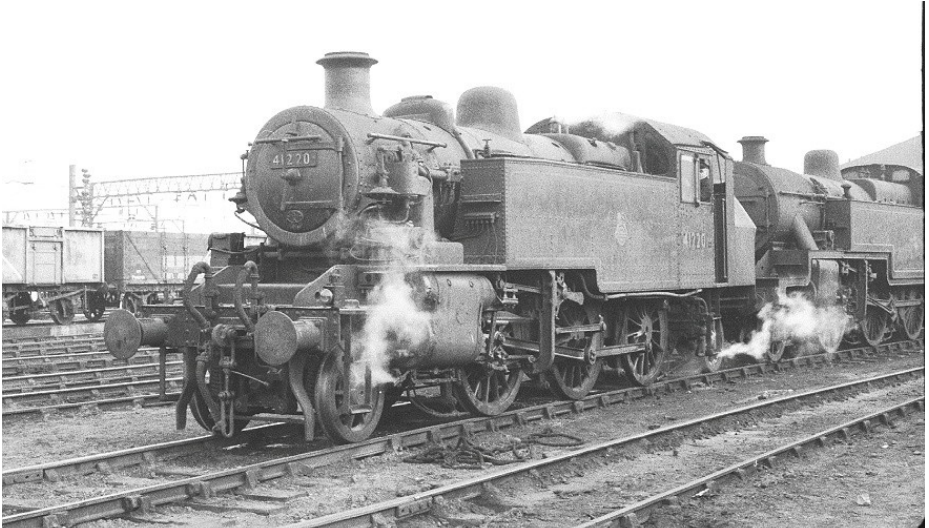
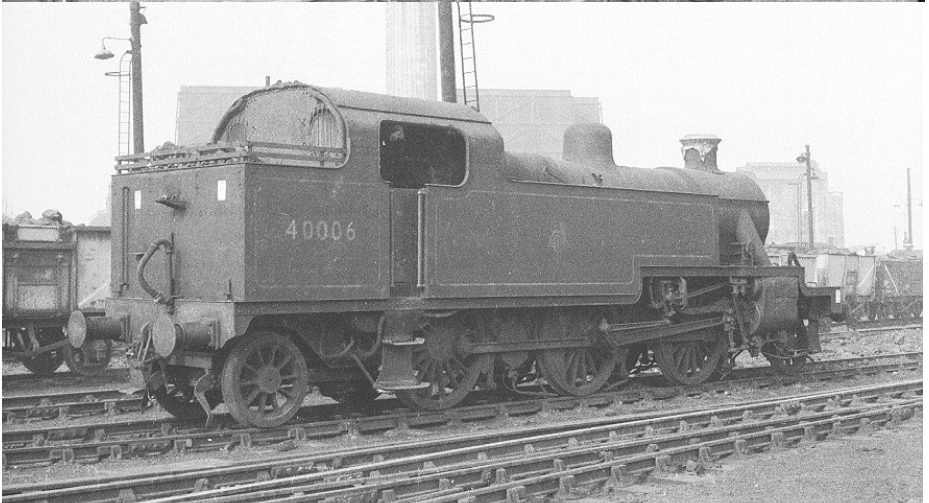
Two 2-6-2 classes of tank loco very familiar to the author. Top, the more modern Ivatt type introduced in 1946 (much preferred for their crew comforts) and below the older Fowler design, which dated back to the 1930's.
Photos: Peter Elmslie.

Engines Nos. 4, 10, and 20 were Fowler 2-6-2 tanks which were not liked at all; later, the Ivatt 2-6-2 tanks Nos.1200 and 1220 were superb engines. All were fitted for push-pull (or motor working as the official term for locos and coaches so fitted would have it). To commence the two train working, one service left Watford in the morning with two coaches in front and two behind the engine. The leading two were left at St Albans, the extra loco required was attached to one of the morning freight trains.

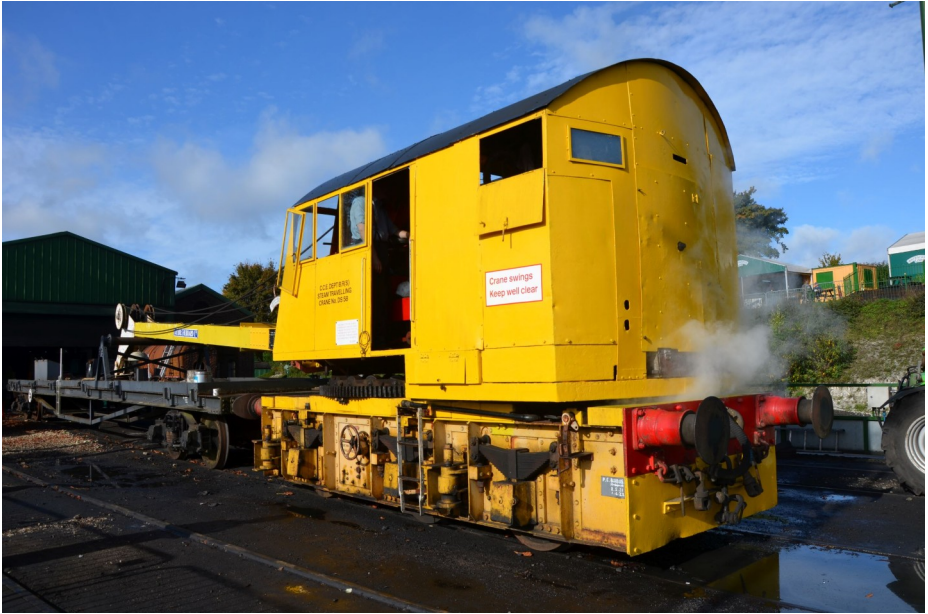
Ten ton crane DS58 built by Taylor and Hubberd of Leicester in 1955 and used at Woking Pre Assembly Depot.
